Assessment of Photovoltaic Module Failures in the Field

Report IEA-PVPS T13-09:2017

IEA PVPS Task 13, Subtask 3
Report IEA-PVPS T13-09:2017
May 2017

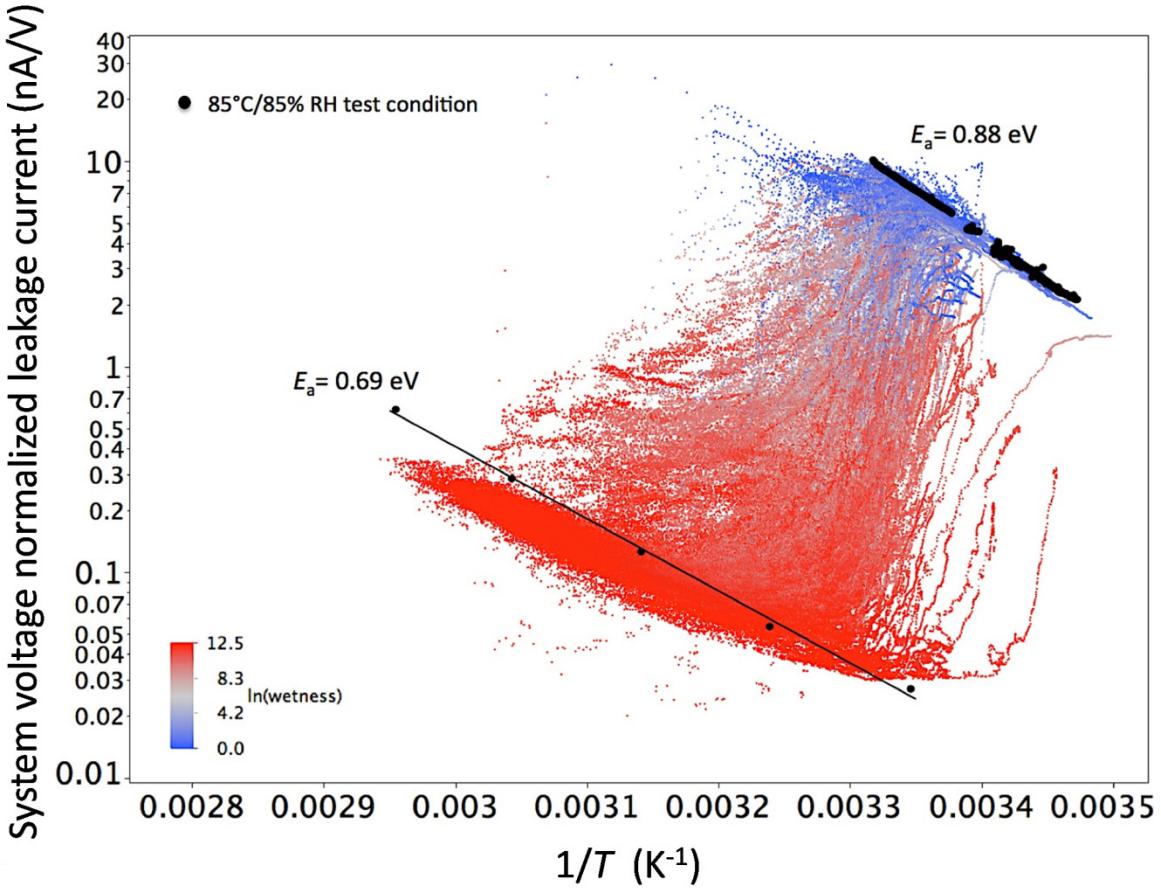
Current transferred from the active cell circuit to ground in thin-film modules under system voltage stress in Florida can be seen with respect to meteorological data in Fig. 68. For reference, superimposed are current transfer curves obtained in chamber tests at 10% relative humidity and in a water bath (wet leakage current testing conditions). With this, functions predicting the mode and rate of coulomb transfer can be developed for use in estimating the relative PID stress associated with temperature, moisture, and system voltage and then applied to other climates.

Fig. 68: System voltage-normalized current over a period of about six months for a module held by edge clips in Florida, USA (red-blue data, where blue is wet and red is dry according to the wetness sensor). Results in a dry chamber (10% RH, five lower points), wet leakage current tests (upper data) and for the 85°C 85% RH chamber test condition performed on a sister module are superimposed in black.

Linear regression models fitted to data obtained for the thin-film modules shown in Fig. 68 are performed. Considering the exponential function of current on module temperature T and relative humidity RH [235][236], the resulting model equations for current transfer give approximately order of magnitude accuracies for I_{leak}/V . These predictive model functions for the system voltage normalized leakage current determined for the thin-film module based on Florida data are as follows:

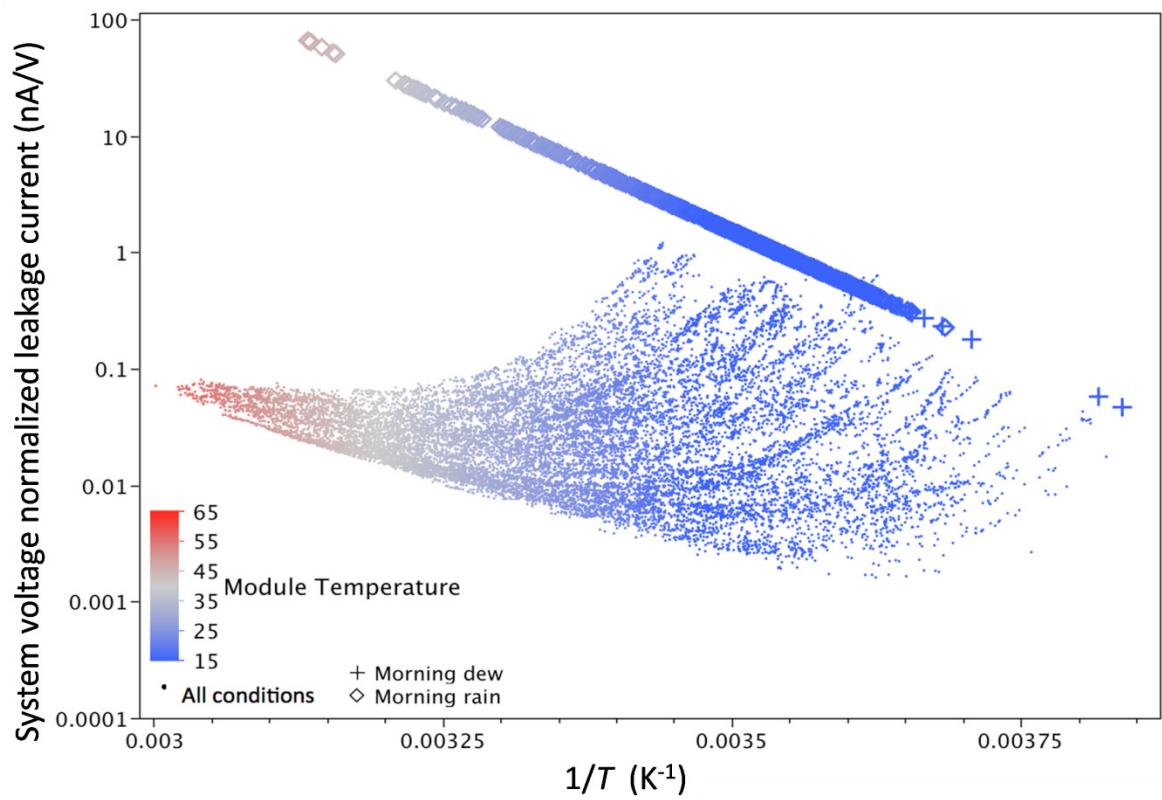
Fig. 69: Calculated current transfer from a module in Colorado, showing current transfer with Arrhenius relationship when the module is wet and the result of the regression function derived from Florida data when humidity is uncondensed.

These equations are projected onto a module temperature and field meteorological data in Colorado, USA, to predict the coulombs transferred for a year in Colorado in Fig. 69. Summing up the current transfer data for Florida (Fig. 68) and Colorado (Fig. 69), total coulombs transferred in Colorado are found to be lower, calculated to be overall 19% of that of Florida, primarily associated with minimal morning dew and lower humidity as seen in Fig. 70.

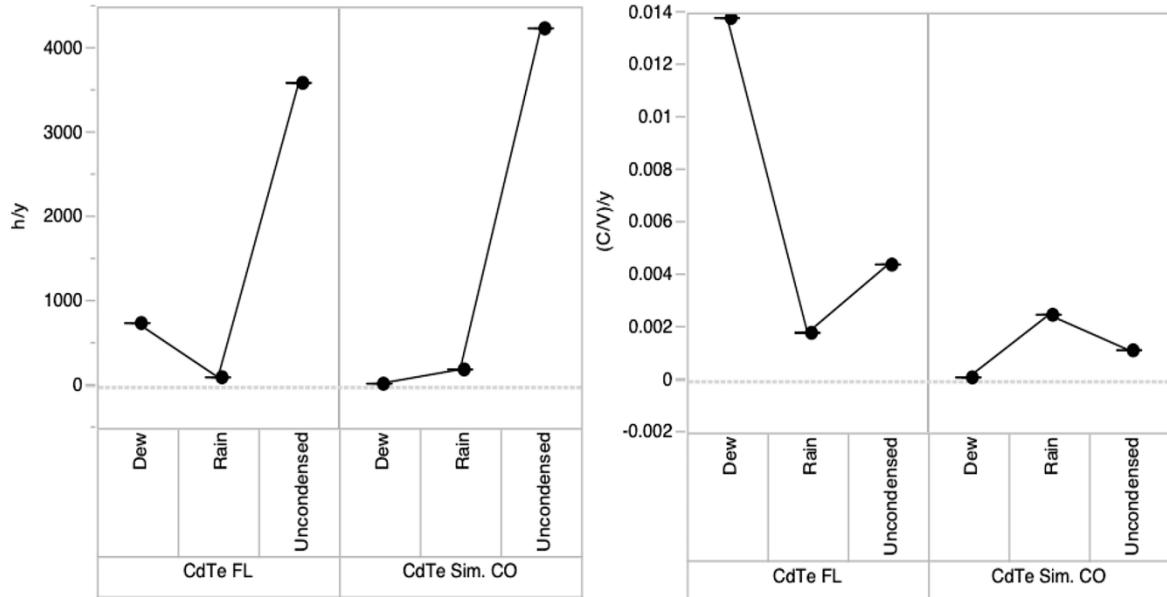
Fig. 70: (a) Time at each surface state, and (b), charge transferred for a CdTe module measured in Florida (FL) and simulated in Colorado (CO).
